**Flood Control Project Maintenance
Levee Inspections**

Maintenance Issue Types Only, Levee Inspection Report By Mile - Spring 2019

Reclamation District No. 0010 Honcut

Waterway	Bank	Unit Miles	Inspection Start/End	Inspector
Unit No. 01 Simmerly Slough	Right	7.65	05/16/2019 05/16/2019	Sterling York

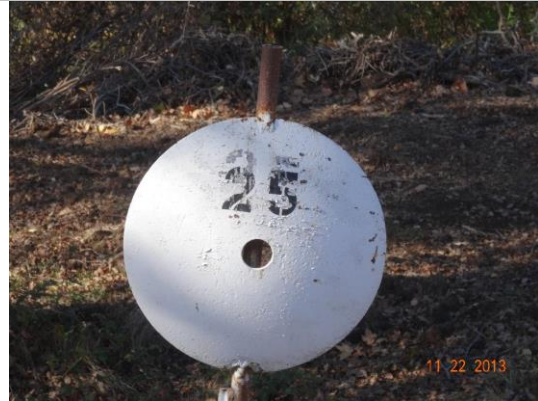
Photo 1 of 3 : UCIP_SP_2019_24840_44753.jpg

Comment Code						
Inspector Comment						
FS_ID:24840 DS_ID:21305 EP_NO: N/A Repair Type: Non-Urgent Crossing Status: Found UCIP Comments: 04/30/2013 Burrow activity--large holes found on landward side. Crossing on landward side is blocked. Recommend clearing headwall and crossing. Need to coordinate with owner to determine status of crossing. If crossing is no longer in use owner will need to contact the CVFPB to comply with Title 23. This crossing is referenced in the USACE Periodic Inspection as item USACE_CESPK_HON2_2013_p_0476. (DWR UCIP - O. Magana) FIELD_STRUCT_DESC: 24-inch corrugated metal gravity drainage pipe through the levee, 7.5 feet below the crown. Corrugated metal cutoff wall around the pipe at each shoulder. Flap gate on the waterside (WS) end. Concrete headwall at each toe. Saddle and apron on the WS. [Additional Reference(s): DWR Levee Log, 2005. USACE Sacramento O&M Manual 151, May 1953, (Station 674+73)]. FS Date: 4/30/2013

Marker visible on waterward side, crossing is referenced as No. 25.

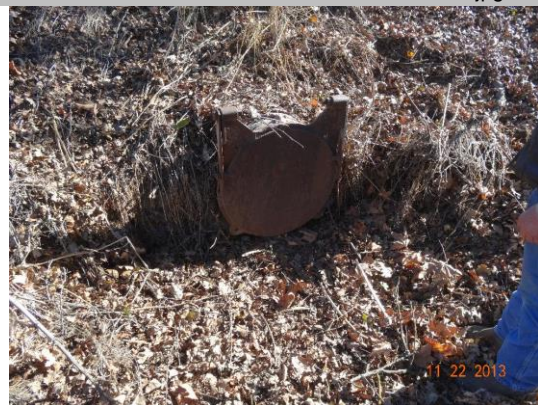
Photo 2 of 3 : UCIP_SP_2019_24840_44752.jpg

View of flap gate located on waterward side.

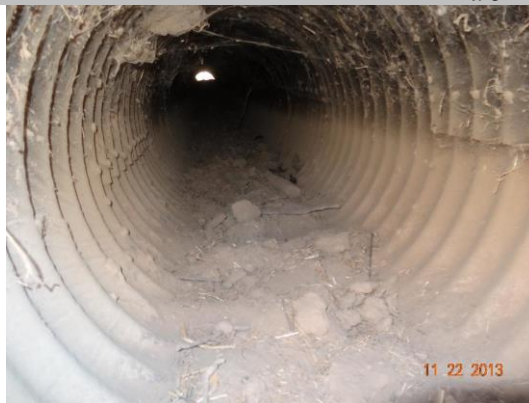
Photo 3 of 3 : UCIP_SP_2019_24840_44751.jpg

Comment Code						
Inspector Comment						
FS_ID:24840 DS_ID:21305 EP_NO: N/A Repair Type: Non-Urgent Crossing Status: Found UCIP Comments: 04/30/2013 Burrow activity--large holes found on landward side. Crossing on landward side is blocked. Recommend clearing headwall and crossing. Need to coordinate with owner to determine status of crossing. If crossing is no longer in use owner will need to contact the CVFPB to comply with Title 23. This crossing is referenced in the USACE Periodic Inspection as item USACE_CESPK_HON2_2013_p_0476. (DWR UCIP - O. Magana) FIELD_STRUCT_DESC: 24-inch corrugated metal gravity drainage pipe through the levee, 7.5 feet below the crown. Corrugated metal cutoff wall around the pipe at each shoulder. Flap gate on the waterside (WS) end. Concrete headwall at each toe. Saddle and apron on the WS. [Additional Reference(s): DWR Levee Log, 2005. USACE Sacramento O&M Manual 151, May 1953, (Station 674+73)]. FS Date: 4/30/2013

Internal view of pipe wall from waterward side.

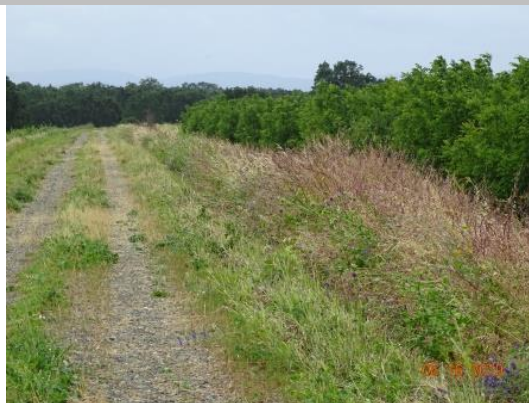
Photo 1 of 1 : SP_2019_RD0010_165_7_20190520_00013.jpg

LM Start	0.47	Rating **	A	Issue No.	7
LM End	1.21	Issue Type +	Ma	Location *	WS
Category	Earthen Levee			GPS Latitude/Longitude	
				Start	End
Item	Vegetation			39.310243 °	39.306435 °
				-121.607588 °	-121.595072 °
DWR ID	DWR_RD0010_03_s_2019_7				
Comment Code					
V1 : Control annual grass and weeds on the levee slopes and easements.					
Inspector Comment					
The annual vegetation needs to be maintained, Spring 2019.

View looking downstream at the waterside of the annual vegetation that needs maintenance, Spring 2019.

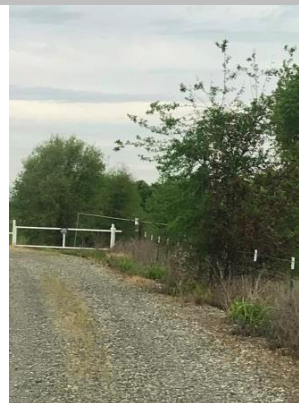
Photo 1 of 1 : SP_2019_RD0010_165_10_20190305_00003.jpg

LM Start	1.10	Rating **	M	Issue No.	10
LM End	1.10	Issue Type +	Ma	Location *	WS
Category	Earthen Levee			GPS Latitude/Longitude	
				Start	End
Item	Trim / Thin Trees			39.306995 °	39.306995 °
				-121.597116 °	-121.597116 °
DWR ID	DWR_RD0010_03_s_2018_10				
Comment Code					
T2 : Thin trees to allow visibility of the ground and room to flood fight.					
Inspector Comment					
Tree needs to be trimmed for access and visibility.

View looking downstream waterside of a tree that needs to be trimmed for access and visibility.

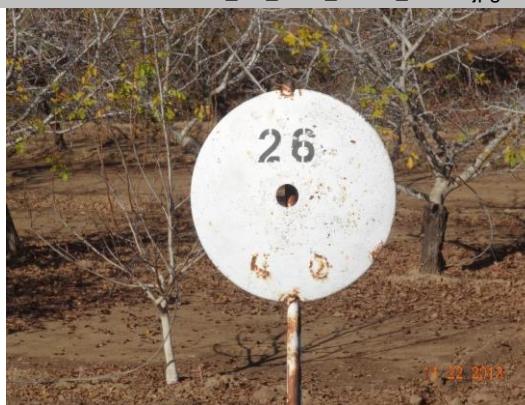
Photo 1 of 3 : UCIP_SP_2019_24842_44764.jpg

Comment Code						
Inspector Comment						
FS_ID:24842						
DS_ID:21307						
EP_NO: N/A						
Repair Type: Non-Urgent						
Crossing Status: Found						
UCIP Comments: 05/01/2013 Sediment deposit inside pipe--Need to coordinate with owner to determine status of crossing. If crossing is no longer in use owner will need to contact the CVFPB to comply with Title 23. (DWR UCIP - O. Magana)						
FIELD_STRUCT_DESC: 24-inch corrugated metal gravity drainage pipe through the levee, 15 feet below the crown. Corrugated metal cutoff wall around the pipe at each shoulder. Flap gate on the waterside (WS) end. Slide gate on the landside (LS) end. Concrete headwall at each toe. [Additional Reference(s): DWR Levee Log, 2005. USACE Sacramento O&M Manual 151, May 1953, (Station 134+06)].						
FS Date: 5/1/2013

Marker visible on waterward side--No. 26.

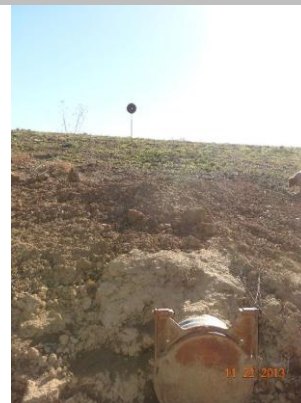
Photo 2 of 3 : UCIP_SP_2019_24842_44762.jpg

Comment Code						
Inspector Comment						
FS_ID:24842						
DS_ID:21307						
EP_NO: N/A						
Repair Type: Non-Urgent						
Crossing Status: Found						
UCIP Comments: 05/01/2013 Sediment deposit inside pipe--Need to coordinate with owner to determine status of crossing. If crossing is no longer in use owner will need to contact the CVFPB to comply with Title 23. (DWR UCIP - O. Magana)						
FIELD_STRUCT_DESC: 24-inch corrugated metal gravity drainage pipe through the levee, 15 feet below the crown. Corrugated metal cutoff wall around the pipe at each shoulder. Flap gate on the waterside (WS) end. Slide gate on the landside (LS) end. Concrete headwall at each toe. [Additional Reference(s): DWR Levee Log, 2005. USACE Sacramento O&M Manual 151, May 1953, (Station 134+06)].						
FS Date: 5/1/2013

View of waterward slope.

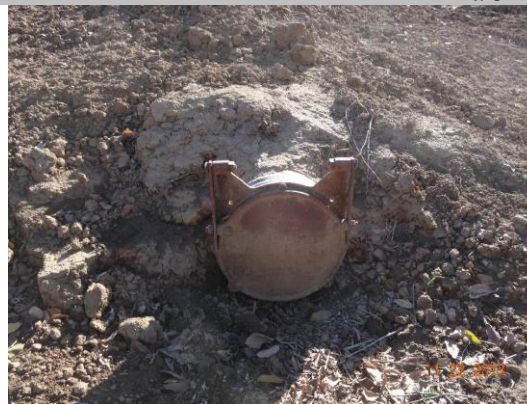
Photo 3 of 3 : UCIP_SP_2019_24842_44763.jpg

View of flap gate located on waterward side.

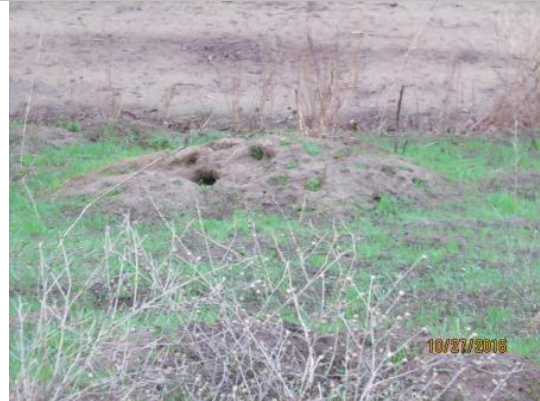
Photo 1 of 1 : SP_2019_RD0010_165_6_20190305_00001.jpg

LM Start	1.72	Rating **	M	Issue No.	6
LM End	1.72	Issue Type +	Ma	Location *	WS
Category	Earthen Levee			GPS Latitude/Longitude	
				Start	End
Item	Animal Control			39.303262 °	39.303262 °
				-121.587680 °	-121.587680 °
DWR ID	DWR_RD0010_03_f_2016_6				
Comment Code					
A3 : No rodents visible, but rodent burrows visible; need to backfill and compact or grout burrows.					
Inspector Comment					
No squirrel activity seen, but rodent holes need to be back filled properly, Spring 2019.

View of waterside slope, no squirrel activity seen, but rodent holes need to be back filled properly.

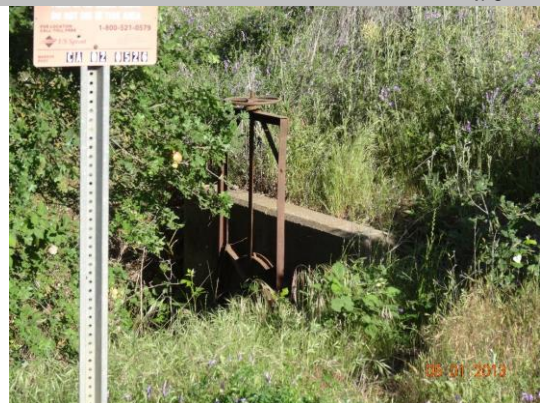
Photo 1 of 2 : UCIP_SP_2019_24883_44820.jpg

Comment Code					
Inspector Comment					
FS_ID:24883 DS_ID:21308 EP_NO: N/A Repair Type: Non-Urgent Crossing Status: Found UCIP Comments: 05/01/2013 Dense vegetation limits the inspector's visibility to identify signs of pipe failure (leaks) along the slope. Recommend removing vegetation along pipe alignment to conduct proper inspection of structure and appurtances. (DWR UCIP - O. Magana) FIELD_STRUCT_DESC: 24-inch corrugated metal gravity drainage pipe through the levee, 12 feet below the crown. Corrugated metal cutoff wall around the pipe at each shoulder. Flap gate on the waterside (WS) end. Slide gate on the landside (LS) end. Concrete headwall at the LS toe. [Additional Reference(s): DWR Levee Log, 2005. USACE Sacramento O&M Manual 151, May 1953, (Station 192+33)]. FS Date: 5/1/2013

View of slide gate and concrete headwall located on landside.
